## ERCOUPE: LOW TAIL SYNDROME AS A SAFETY ISSUE

**APPLICABLE TO:** Ercoupe 415-C, CD, D, E, G, F-1, F-1A and Alon Aircraft that are equipped with either the welded steel or aluminum trailing link MLG assemblies; serial numbers 112 and up.

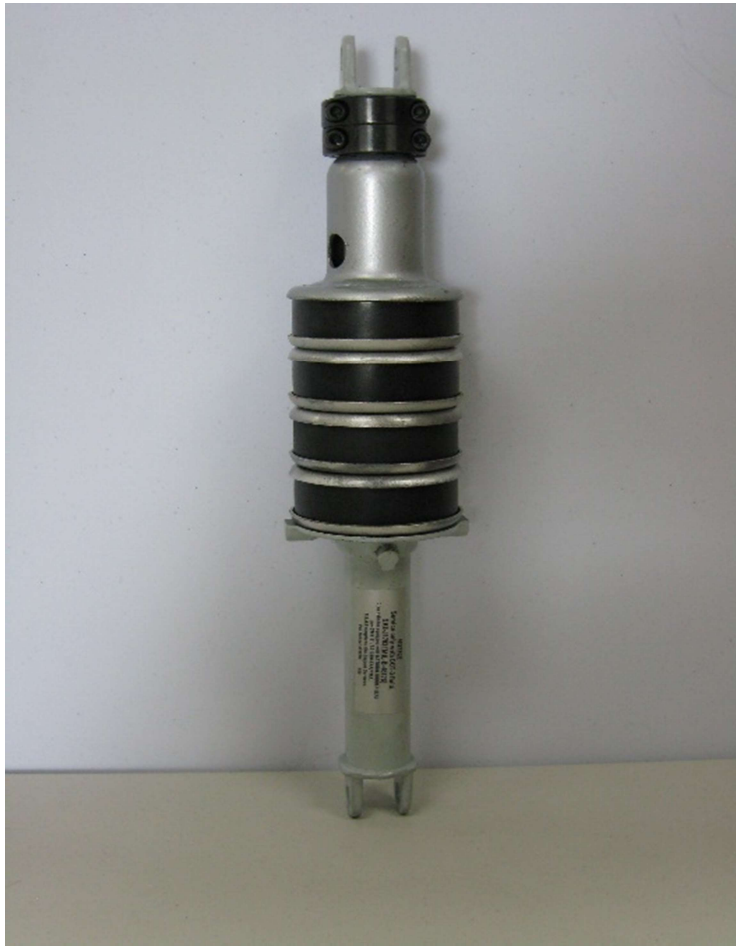
Main Landing Gear Oleo Assembly with Spacers Installed
