# ALERT SERVICE BULLETIN

RESTRAINT SYSTEMS - OPERATORS OF AIRCRAFT WITH PACIFIC  
SCIENTIFIC COMPANY, HTL/KIN-TECH DIVISION  
RESTRAINTS INSTALLED

**A25-1124A**

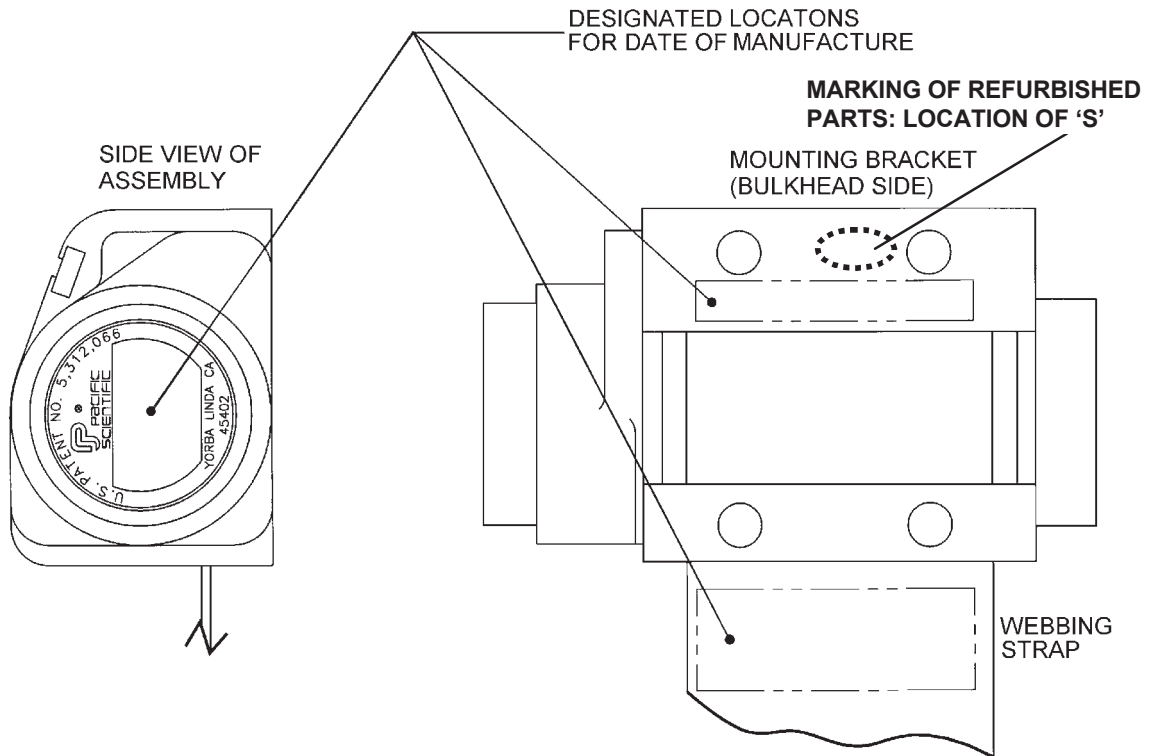
Parts serviced or refurbished will be ink stamped with the date and an “S” on the back of the frame. This stamp will indicate the Aluminum shaft has been replaced with the Steel shaft. (See Figure 1.)

Figure 1. Location of Manufacturer's Date and Marking of Refurbished Parts
