# PIPER PA23 AIRCRAFT

## Three Point Torso Restraint System Installations

PA-23, PA23-160, PA-23-235, PA-23-250, PA-23-E250

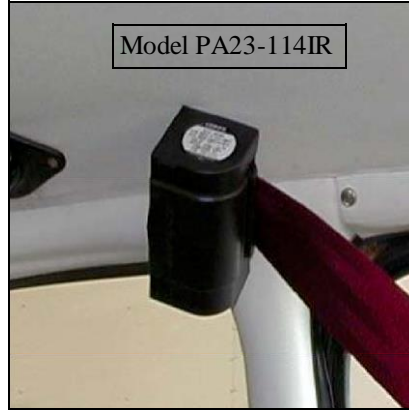
Model Number	Product Description
PA23-114FS	Three-point restraint system, TSO-C114, Fixed torso strap
PA23-114IR	Three-point restraint system, TSO-C114, Inertial reel torso strap

STC SA02298CH authorizes the installation of a vendor supplied, FAA approved, TSO-C114 restraint system, at each pilot position. The restraint system incorporates a traditional pelvic restraint strap (lap belt) provided with the provision to attach, as needed, a single diagonal upper torso (shoulder) restraint strap. The upper end of the shoulder strap is hard mounted to the airframe at a location aft and above the pilot position. The free end of the shoulder strap is attached to the pelvic restraint strap at the buckle location and adjusted, as necessary, by use of the cinch strap or inertial reel.

Model PA23-114IR has a location of station 66.35 and a net weight change of 3.50 pounds per installation; two pilot positions.
